CPTED AUDIT OF WESTON ROAD AND LAWRENCE AVENUE WEST

2022.11.22

Audit report prepared by 12 Division's CPTED Audit Team. November 2022.

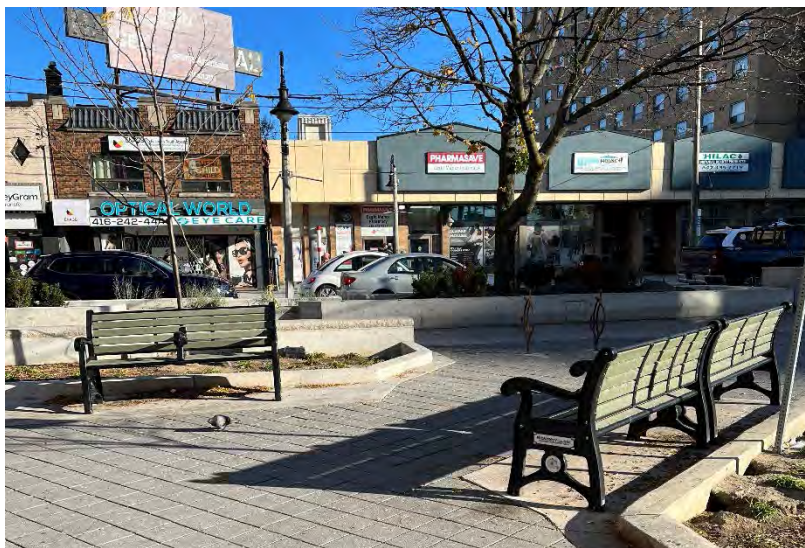
Southwest corner of Weston Rd and Lawrence Ave W.

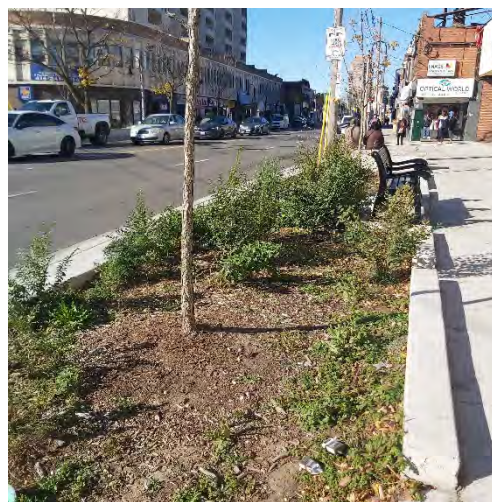
Neglected planters.

Few plants survive in the raised planters. The beds accumulate garbage that includes discarded beer and alcohol bottles. The edges of the planters serve as seating areas that augment the three benches installed by the Weston Village BIA. The elevated curb around the Royal Bank building also serves as an unofficial sofa which is being utilized on a daily basis.

To discourage prolonged seating on the planters, 3 – 5” boulders could be placed unevenly on the surface of the planter walls and sealed in with concrete. Alternately, wrought iron mini-fencing can be embedded in the edges of the planters. Yet a third option is to install inverted “T” bars along the planter walls with wedge anchors and adhesive. This treatment can also be applied to the curb around the RBC building. At least two of the three benches could be moved to alternate locations along the strip to lessen the chance of congregating.

- That planters be rejuvenated appropriately.
- That all light fixtures be properly cleaned and re-lamped with LED bulbs.
- That super-hydrophobic paint be applied to areas where public urination is an issue.

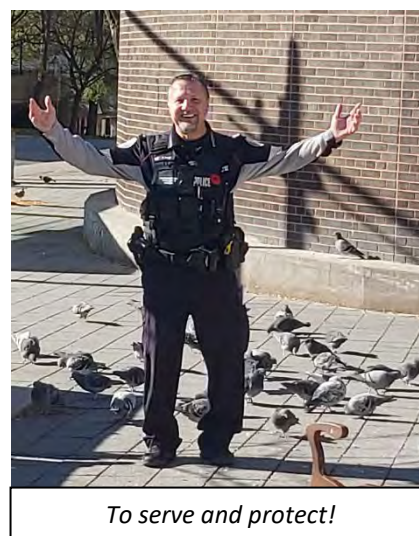
To serve and protect!

There are companies that provide falcons and hawks to initially chase away the pigeons. After that, lifelike decoys of falcons, hawks and/or owls can be mounted around the RBC building. However, these will need to be changed regularly as the pigeons habituate to static images. Another option is to install bird slides or bird wire on the ledges immediately above the brickwork of the RBC building that will prevent them getting a grip on the ledge. However, this will not prevent them from roosting on the hydro wires.

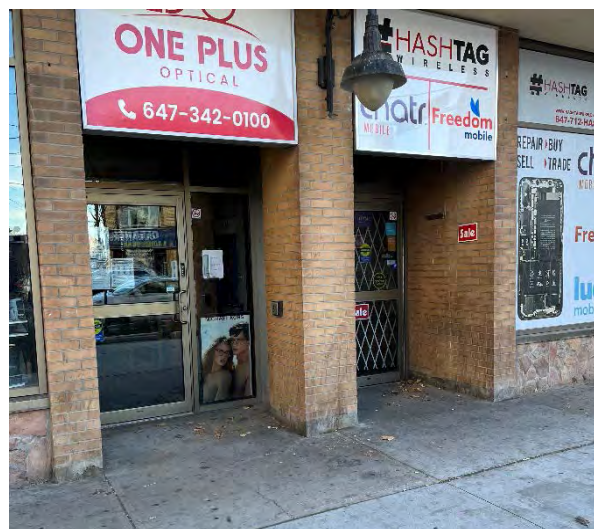
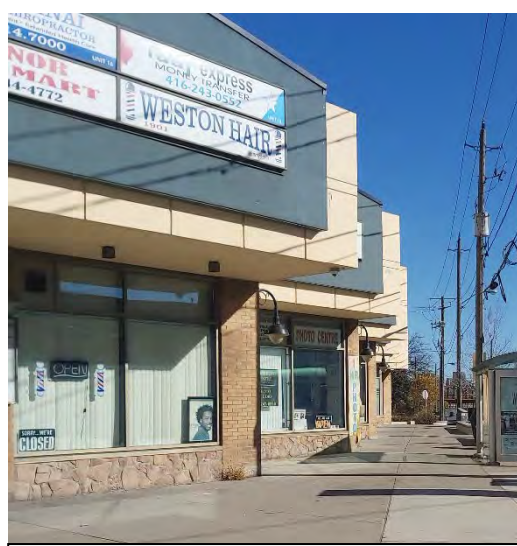
Angled storefronts at 1901 Weston Rd

In a variation of this theme, the retail section of 1901 Weston Rd is designed with a series of zig-zags such that the storefronts around the building are visible to anyone on the corner looking eastward. While this is a good CPTED strategy for making those entrances visible, the downside is that hidden corners are created.

All of these areas – alcoves and hidden corners – are beset with people using them as toilets. One solution to this problem is to treat the lower walls of these areas with super-hydrophobic paint or coatings.

Motion sensor lighting can be located in vestibules where urination is a problem. The sudden bright light with or without the use of an overhead mounted convex stainless-steel mirror may deter such activity at night.

- That motion sensor lights be installed in all alcoves where loitering and/or public urination is an issue.
- That alcoves be removed in places where it is possible to do so by minor modification.

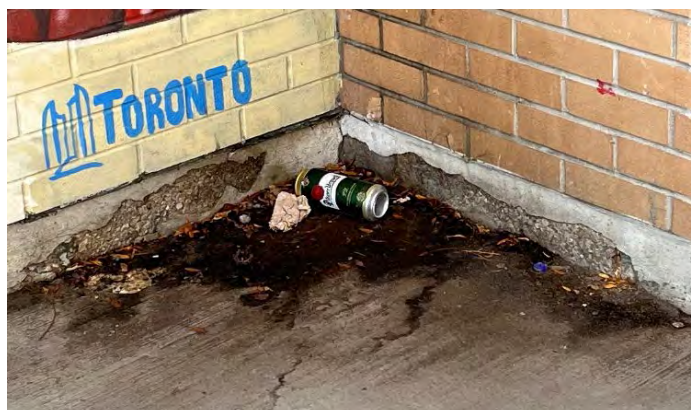
Alcoves used as public toilets. Note the debris in the corners and the deterioration of the walls.

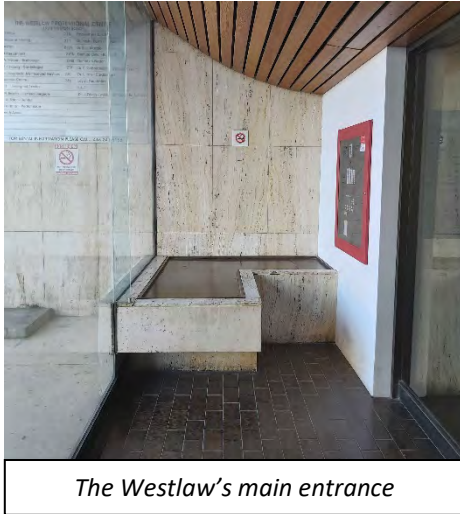
The main entrance to the Westlaw building consists of an interior alcove that gives access to a shop, the elevator to doctors' offices, and to the locked door to the residential units. This makes controlled access problematic. While the street door

The Westlaw's main entrance

could remain unlocked during business hours, it should have key or fob access afterwards to eliminate loitering in the vestibule.

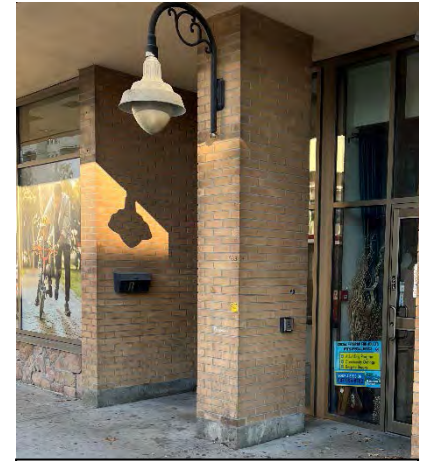
The majority of the lighting in this area is provided by decorative lamps and standard street lamps. However, the covers of the decorative lamps are extremely dirty and hence the illumination provided is seriously compromised. These should be cleaned and the lighting

Note the dirty light fixture.

should be replaced with LED fixtures to increase illumination while decreasing hydro costs.

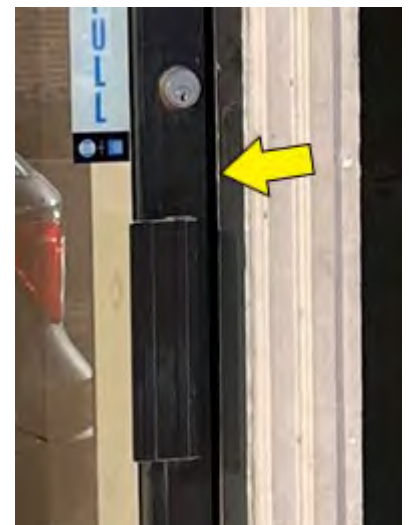
The recommended space between an entry door and the frame is less than 3 mm. This is to prevent access to the deadbolt in a break-and-entry attempt. While most of the doors in this area do have deadbolts, the space between the door and the frame exceeds 3 mm, leaving the bolt exposed. In addition, this extra space can accommodate a crow bar that could be used to pry open the door. The use of an astragal, a plate that covers the gap for the full length of the door, is recommended. Otherwise, a strike cover plate should be installed such that it covers 6" above and 6" below the lock. As a benefit, closing the gap would reduce energy costs.

Note the large gap between the door and its frame (arrow). An astragal or, at minimum, a strike cover plate should cover the lock area.

- That strike cover plates or preferably, astragals, be installed on all doors with more than 3 mm between the door and the frame.
- That all exterior doors be either solid steel or in the case of glass doors, be covered by properly installed break-resistant film.

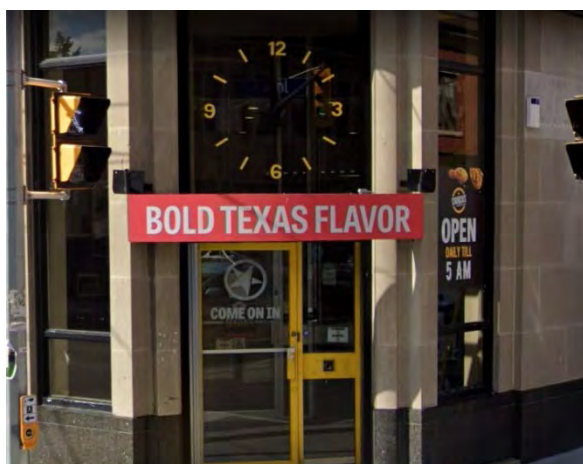
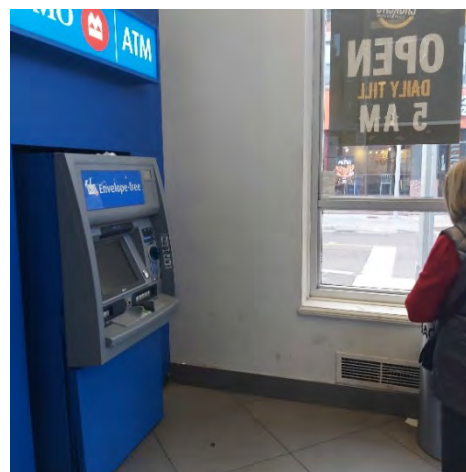
4. Church's Chicken is located in the old BMO building at the corner of Weston Rd and John St. The main entrance does not lead directly into the restaurant but rather to an alcove where the old bank's ATM is located. Staff of Church's Chicken has identified this as a problem area due to loitering, safety concerns for people using the ATM, and for access control to the restaurant giving rise to possible liability issues. The ATM could be re-located for access to the outside. The adjacent window can be reconfigured to accommodate this. The secondary door leading into the restaurant should be removed once this modification has taken place.

This entrance served as access to RBC's ATM as well as the restaurant which is open until 5 AM. The ATM can be moved to the existing window area giving access from the street (Left mage from Google Maps).

- That the ATM at Church's Chicken be relocated for exterior access from John St and the secondary door on the Weston Road entrance to the restaurant be removed.
- That after closing hours of other Weston Rd businesses, Church's Chicken serve only takeout orders through the window adjacent to the exit door on John St.
- That dead spaces be blocked off with fencing.
- That a separate audit be done to assess the effectiveness of the cameras in the area and to compile a catalog of available cameras along with contact information for quick access.
- That all agencies in this area mandated to care for those with addictions and/or mental health issues collaborate to maximize care for those who need their assistance.
- That the Toronto Police Service increase patrols in this area.

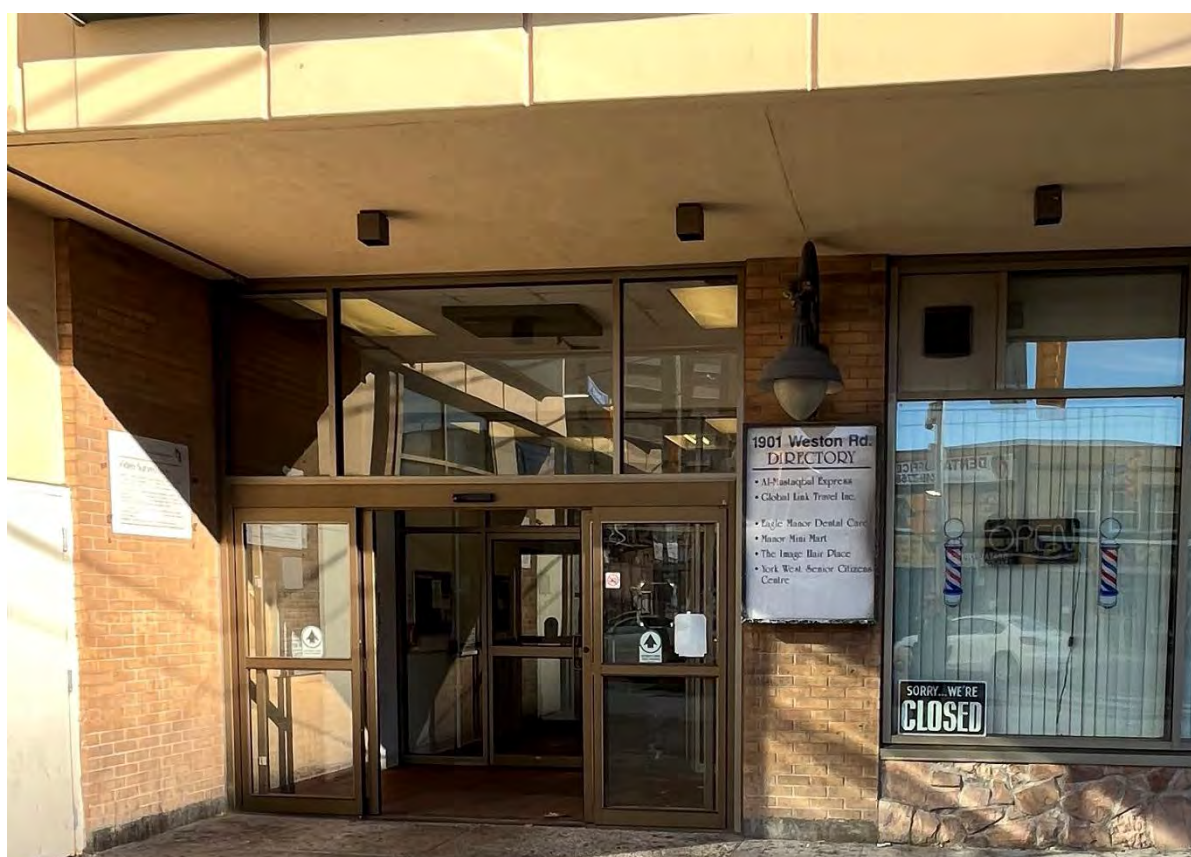
8. The main entrance to 1901 Weston Rd presents a serious challenge. Not only is it an access point to the residential floors, but there are also businesses within the corridor as well as access to York West Active Living. This makes controlling access an issue. Users of this space report a

Entrance to 1901 Weston Rd giving access to the mall, the residential floors and the seniors' centre. The building is home to seniors, Reconnect clients, and Streets to Homes clients.

major loitering problem that often involves drug use and disorderly conduct. It could be beneficial if a committee were formed of TCHC, the various agencies that serve building tenants, York West Services for Seniors, as well as building tenants themselves who could collectively devise strategies to make the building safer for all users.
